MISCELLANEOUS PAPER CERC-87-20

SIDE-SCAN SONAR INVESTIGATION OF BREAKWATERS AT CALUMET AND BURNS HARBORS ON SOUTHERN LAKE MICHIGAN

December 1987

Prepared for US Army Engineer District, Chicago
219 South Dearborn Street
Chicago, Illinois 60604-1797

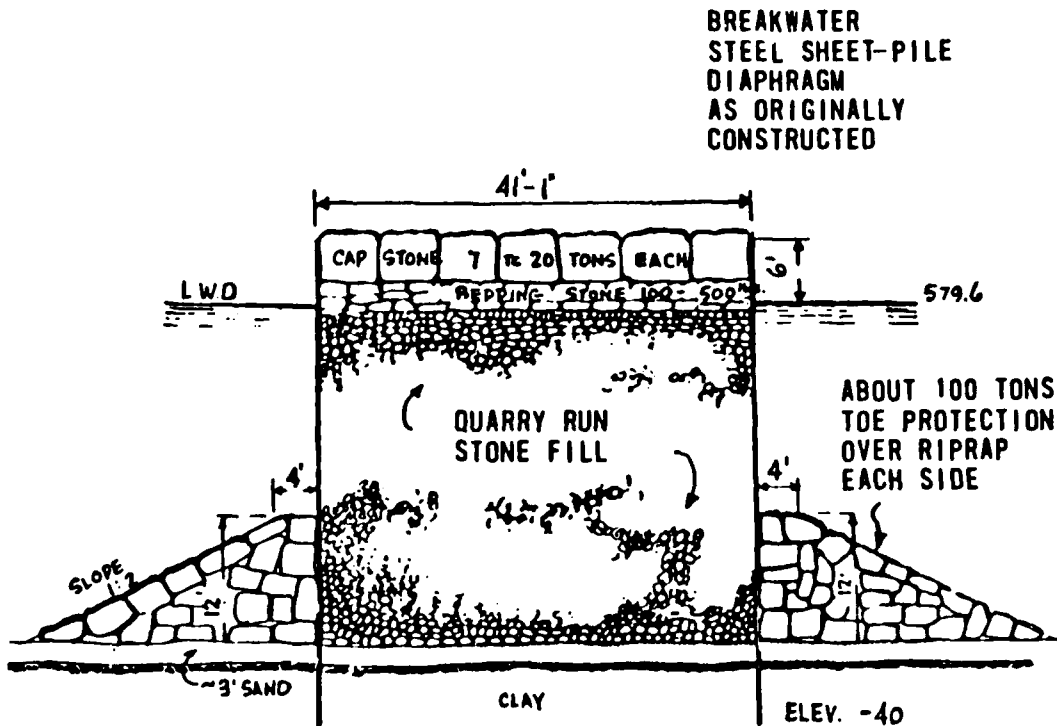
19. The Calumet Harbor detached breakwater constructed in 1935 is composed of 131 stone-filled diaphragm sheet-pile cells (Figure 8). According to the Calumet Harbor Reconnaissance Report (NCC 1985), the piles were driven approximately 2 m into an essentially sandy lake floor, and project maps indicate that some areas were composed of hard limestone.

Figure 8. Cross section of Section C, Calumet Harbor detached breakwater

20. The side-scan sonar survey shows that the harbor floor along most of Section C is predominantly featureless and of low-reflectivity, probably clay. There is no evidence of sand waves or ripples, even near the breach where storm waves in 1984 destroyed two cells and where the wave regime should be more than energetic enough to move noncohesive sediments. Only at the far south end of the breakwater does the lake floor become darker (i.e. demonstrating higher reflectivity), and large fields of ripples can be seen in the records. Here, too, wave action may be moving accumulations of sand which may be spreading over some of the clayey harbor floor.
